TECHNICAL NOTE 1962

STRESSES IN AND GENERAL INSTABILITY OF  
MONOCOQUE CYLINDERS WITH CUTOUTS  
VII - EXPERIMENTAL INVESTIGATION OF CYLINDERS  
HAVING EITHER LONG BOTTOM CUTOUTS OR  
SERIES OF SIDE CUTOUTS

By N. J. Hoff, Bruno A. Boley, and Joseph J. Mele

Polytechnic Institute of Brooklyn

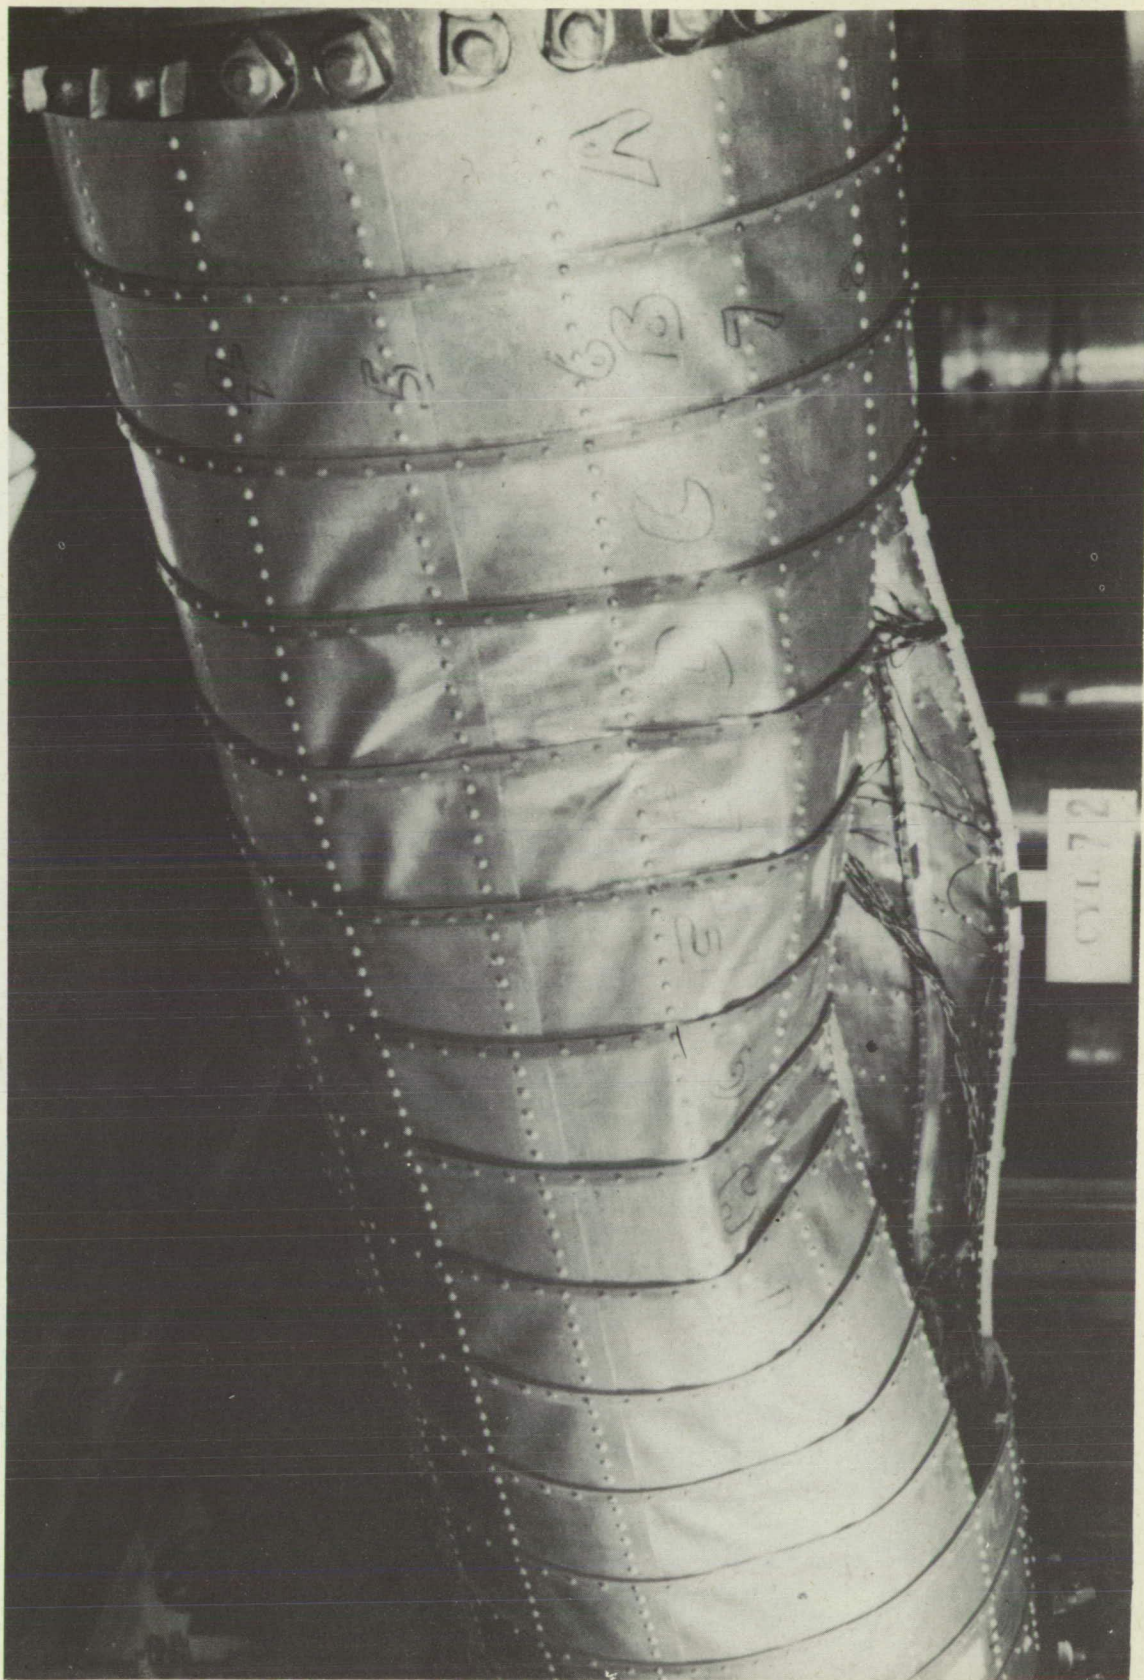
The five cylinders which had bottom cutouts were cylinders 72, 73, 74, 75, and 77. Of these, the first three failed in a definite general-instability pattern. In cylinder 75 failure occurred first by the shearing of two bolts at ring-stringer intersections. The load was then completely removed and the bolts replaced. When the load was reapplied, the specimen failed at a higher moment by the shearing of one of the new bolts and the cracking of an edge stringer at the bolt failure. In cylinder 77, which had the longest cutout, buckling was precipitated by a tension diagonal failure of one of the sheet panels adjacent to the cutout. Except in one side of cylinder 75 where the bolt failure renders the results doubtful, all the buckling shapes of the edge stringers resembled that of a fixed-ended column. The length of the distortion of the edge stringer was slightly longer than the cutout in cylinder 72, slightly shorter than the length of the cutout for cylinders 73, 74, and 75, and about two-thirds the length of the cutout for cylinder 77. The side of cylinder 75 on which the bolts failed was the only edge stringer to fail in an S-shaped curve.

Figure 30.- Side view of cylinder 72 after buckling. Near side or stringer 8.

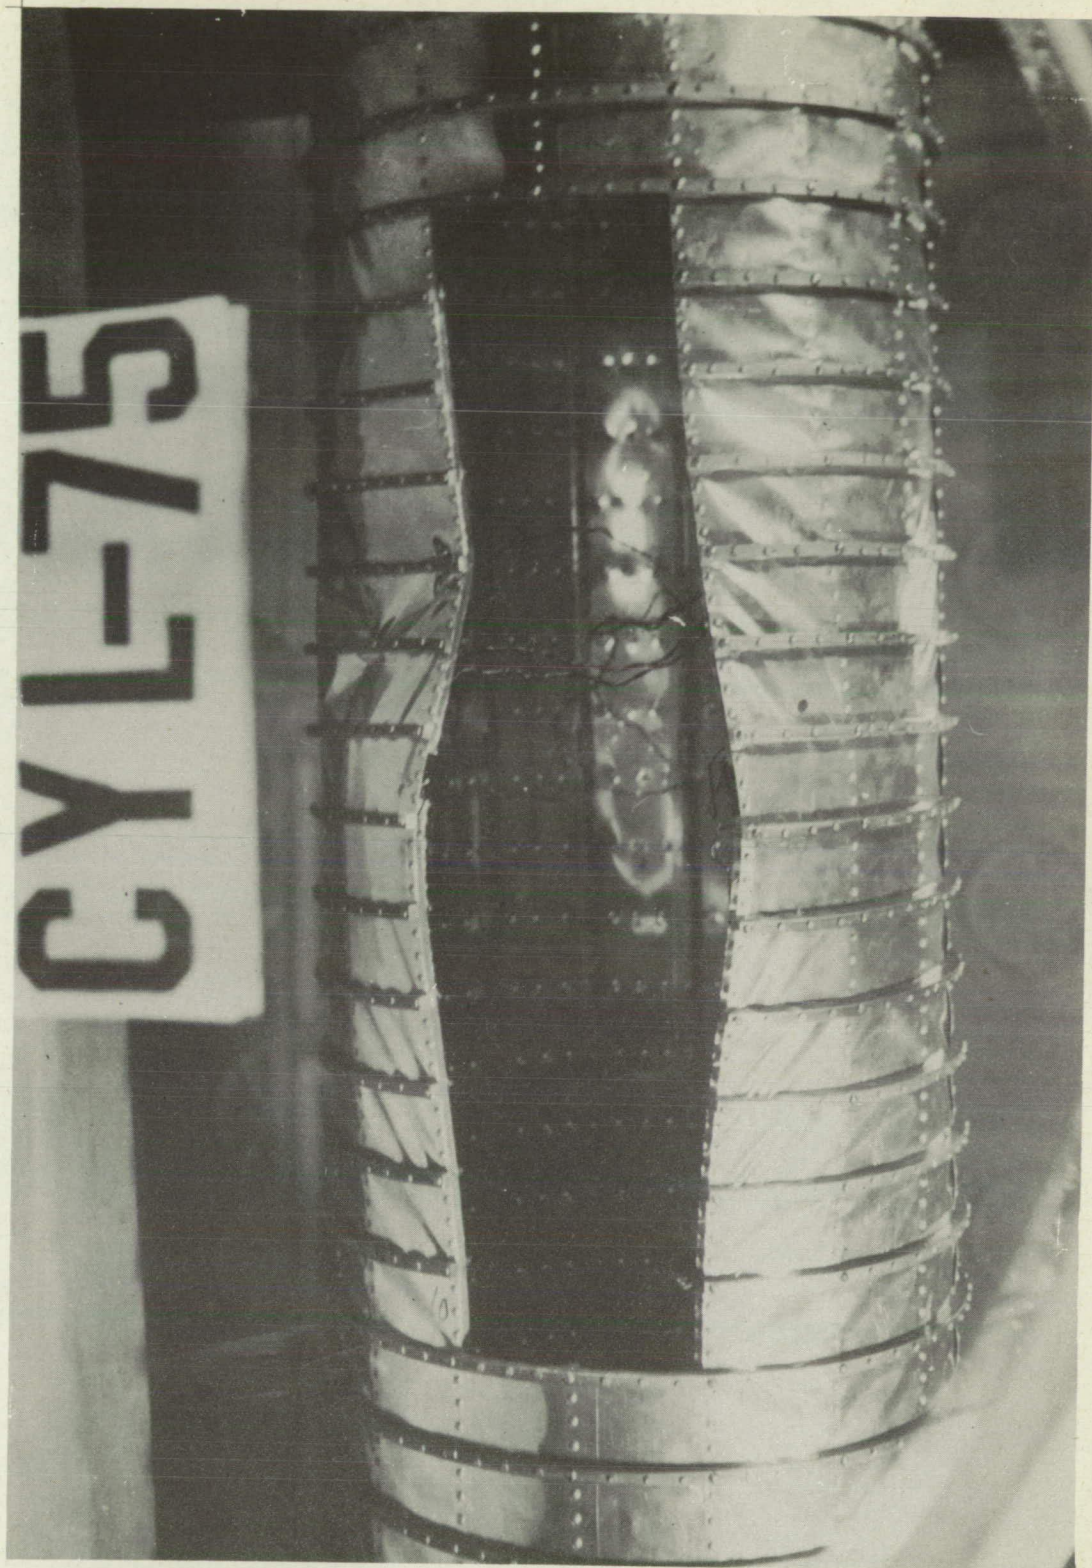
<sup>2</sup>Bolt at intersection of stringer and ring sheared, which precipitated failure that resembled general type of instability.

Figure 34.- Bottom view of cylinder 75 after buckling.

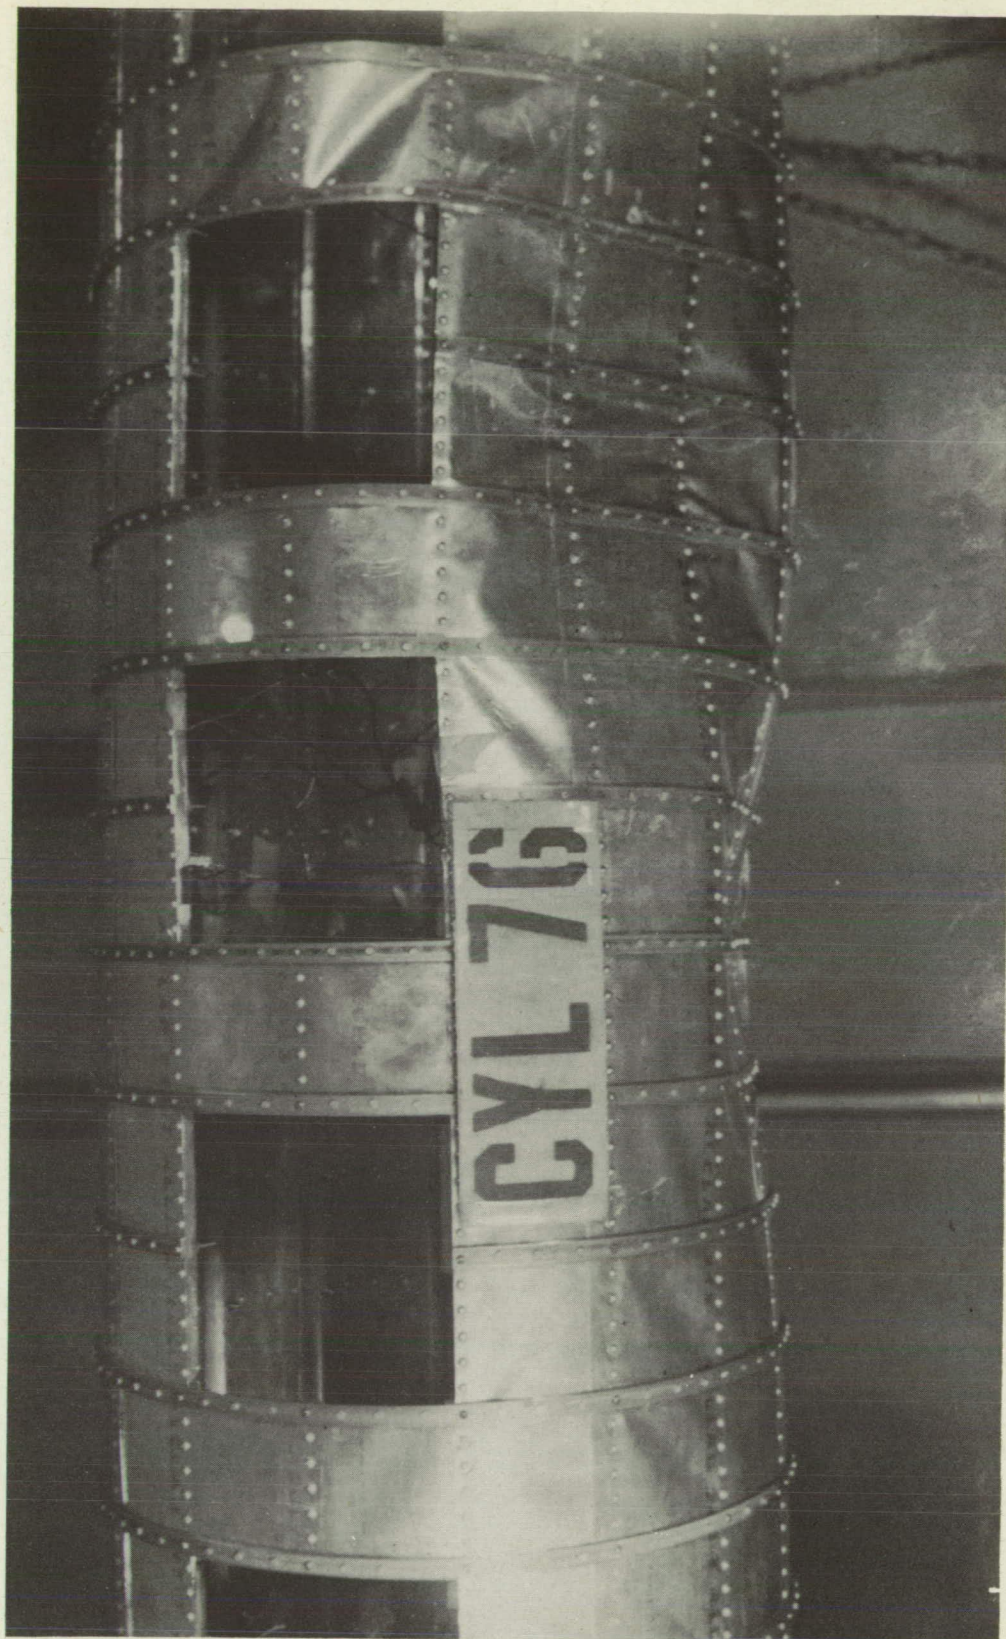
Cylinders 76 and 79 failed at 324,000 and 370,000 inch-pounds, respectively. Both buckled in a general-instability pattern in which the bottom stringer was S-shaped and the sides were pushed in where the bottom stringer buckled out.

Figure 35.- Side view of cylinder 76 after buckling.

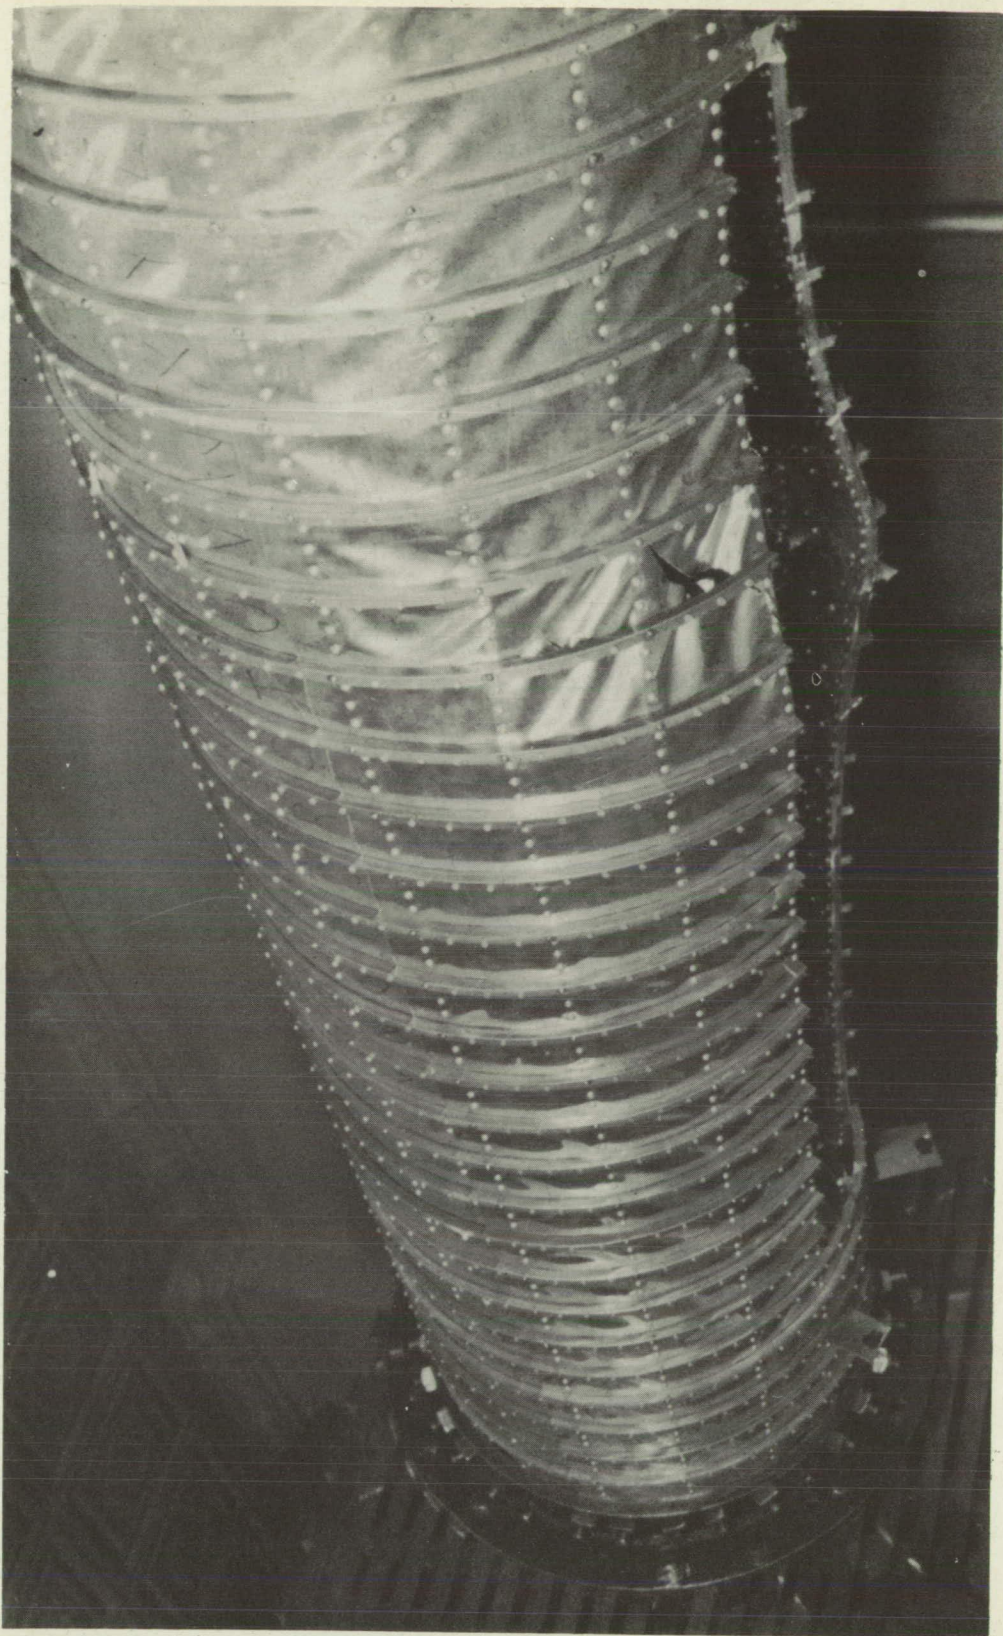
In the edge stringer of cylinder 77 the strains in the middle band were considerably higher than in the full portions of the cylinder. The strain in the cutout region is highest at about the 25-percent mark along the cutout and is lower in the center. Close to failure, however, the pattern changes entirely since the edge stringer takes less than its share while the stringers farther away from the cutout take more. This is true for cylinder 77, the specimen with the longest cutout, but not necessarily for all the others.

Figure 36.- Side view of cylinder 77 after buckling.
